Worldwide repairs carried out with PolymerMetal®

REP-# 099

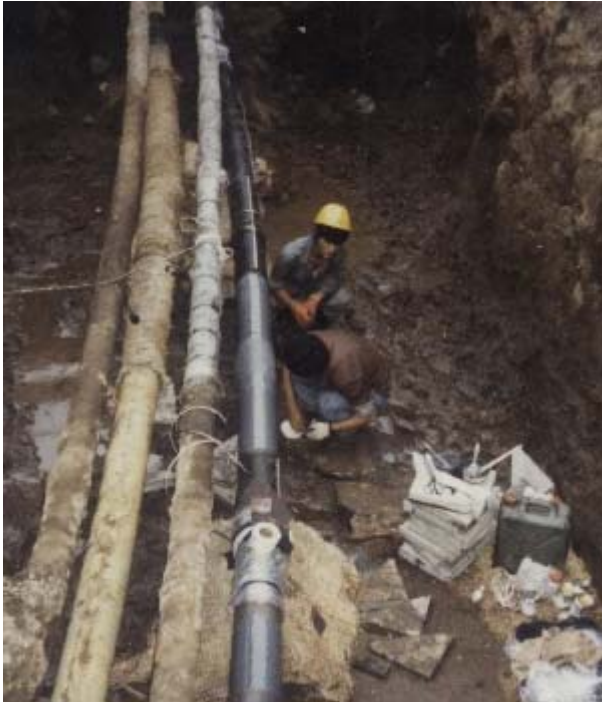
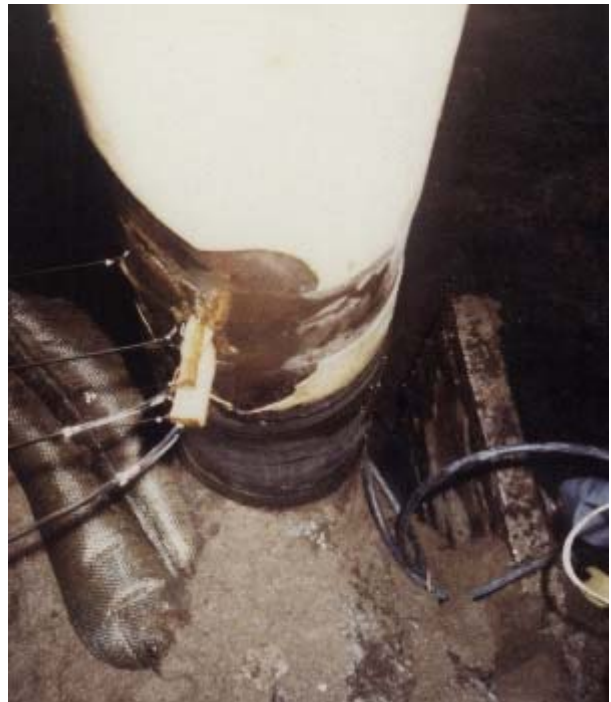
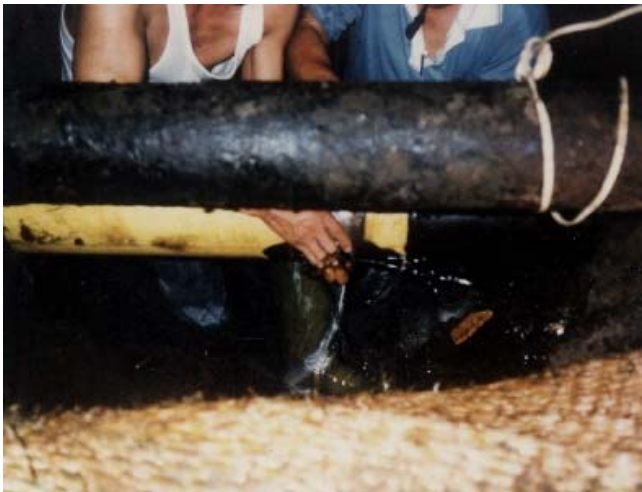
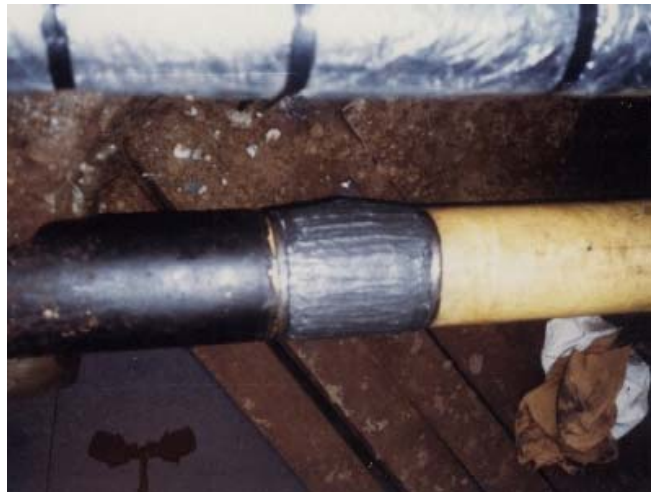
A leakage in a 154 KV P.O.F. insulation pipe was sealed using MM-metal oL-steelceramic and Hardener red working with the direct-MM-bonding method. In addition corrosion damages of the piping were removed by applying MM-metal SS-steel, liquid and Hardener yellow, liquid. Oil pressure 200 psi, diameter of the piping 300 mm, oil quality polybdenum.
