Worldwide repairs carried out with PolymerMetal®

REP-# 092

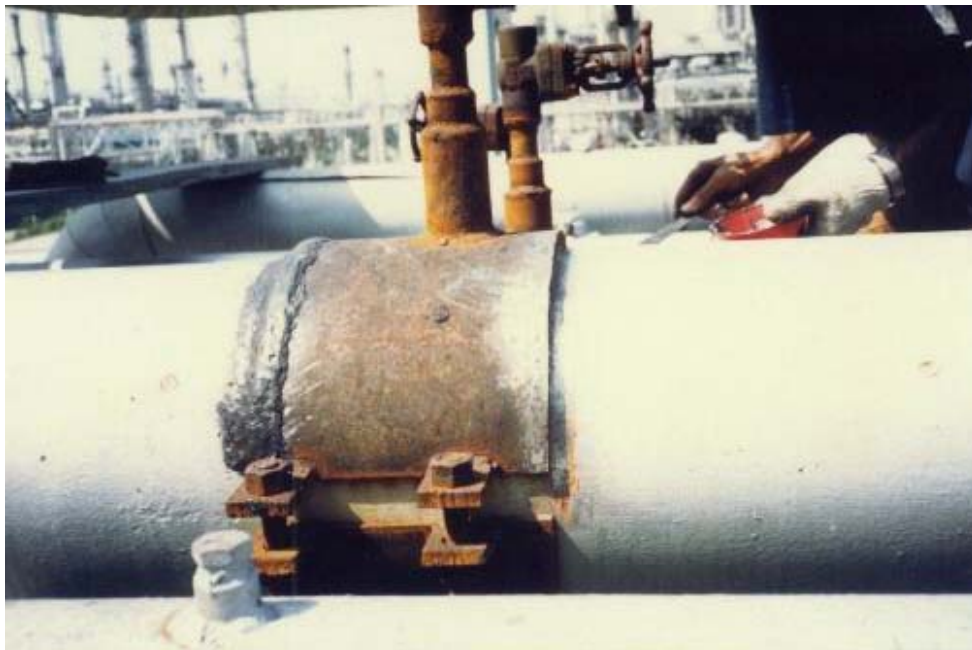
Sealing of 3 hydrogen pipings by using MM-metal SS-steelceramic. Hydrogen was escaping at 350 psi. A metal sleeve with a pressure compensating valve was prepared. MM-metal SS-steelceramic was applied to the sleeve and the pipings. While the valve was open the sleeve was assembled, therefore the hydrogen could easily escape through the opened valve. After totally curing of MM-metal SS-steelceramic the valve was closed and the installation was ready to operate. If the pipings had been exchanged the whole installation would have had to be stopped.
